**LOSS OF HMS SHEFFIELD  
BOARD OF INQUIRY**

**Annex L**

POST ATTACK ANALYSIS

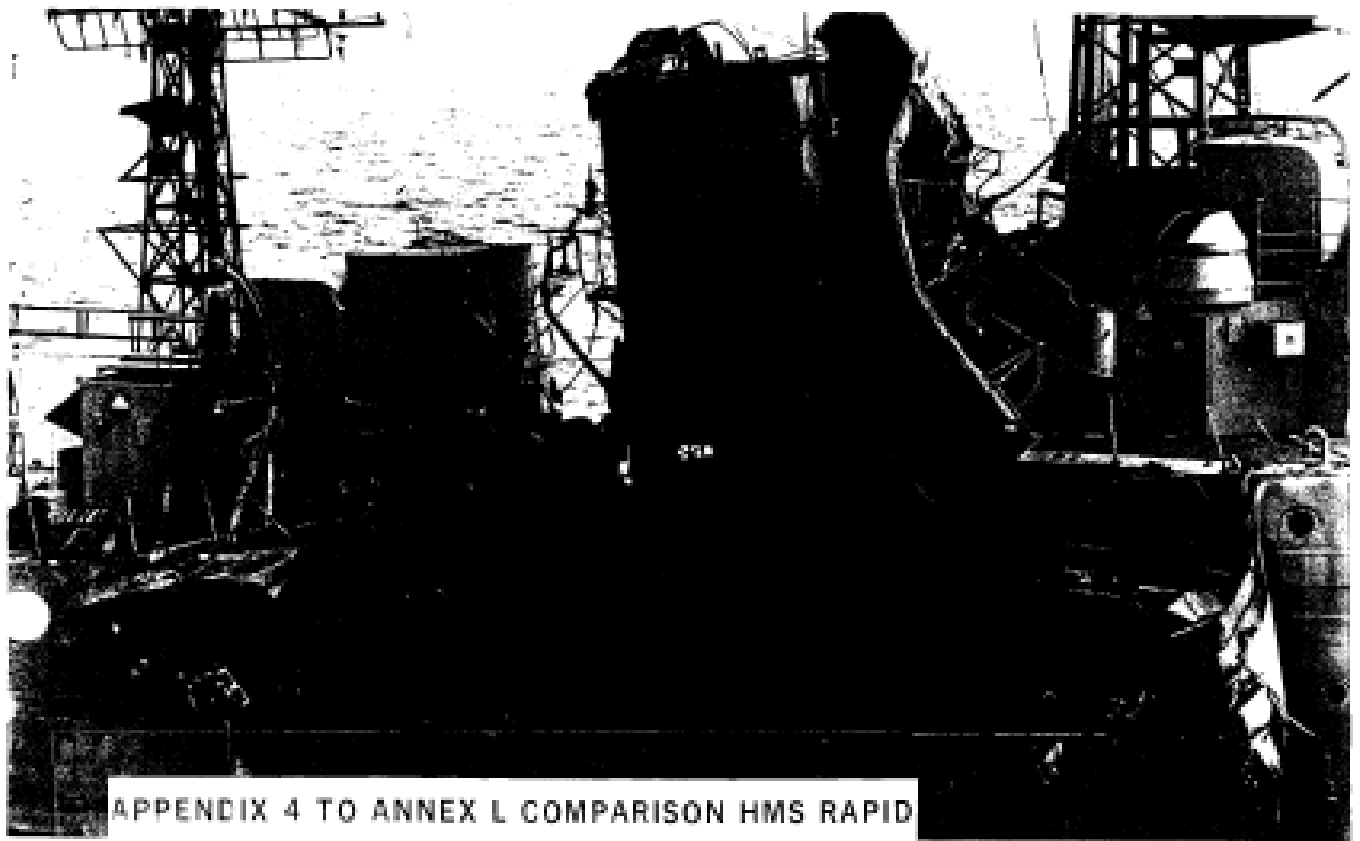
APPENDIX 4 TO ANNEX L COMPARISON HMS RAPID

- a. The external evidence of entry damage was consistent with a high subsonic missile impact at a high angle of incidence. Very similar entry damage had been inflicted by inert SEA EAGLE missiles at comparable angles of incidence. In particular, the rectangular section of plate laid back to 27 bulkhead was a typical result of such an impact.

- b. The damage around the entry hole was not caused by the warhead exploding. By design the warhead should have exploded approximately 10-14 feet after penetrating the hull. This manifestly did not occur. The guard rails, upper deck fittings and boat above the impact point were undamaged. The deck and superstructure were intact.

- c. There was no evidence either from the photographs or from survivor's accounts that correct warhead detonation had occurred. The primary mechanism of the hull rupture seen in HM Ships UNDAUNTED and RAPID is the shock wave from the warhead and not pressure build up. The hypothesis that large uptakes and downtakes in the Forward AMR and Forward Engine Room might have vented the explosion was not supported. Additionally, no damage to the funnel or foremast intakes was evident. Very significant structural damage would have been experienced if the warhead had detonated late in either of these compartments.
