LOSS OF HMS SHEFFIELD BOARD OF INQUIRY

**Report of Captain Salt
Enclosure 3, 4 and 5**

BRIEF NARRATIVE REPORT OF HMS SHEFFIELD ATTEMPTED SALVAGE
OPERATION 8 - 10 MAY 1982

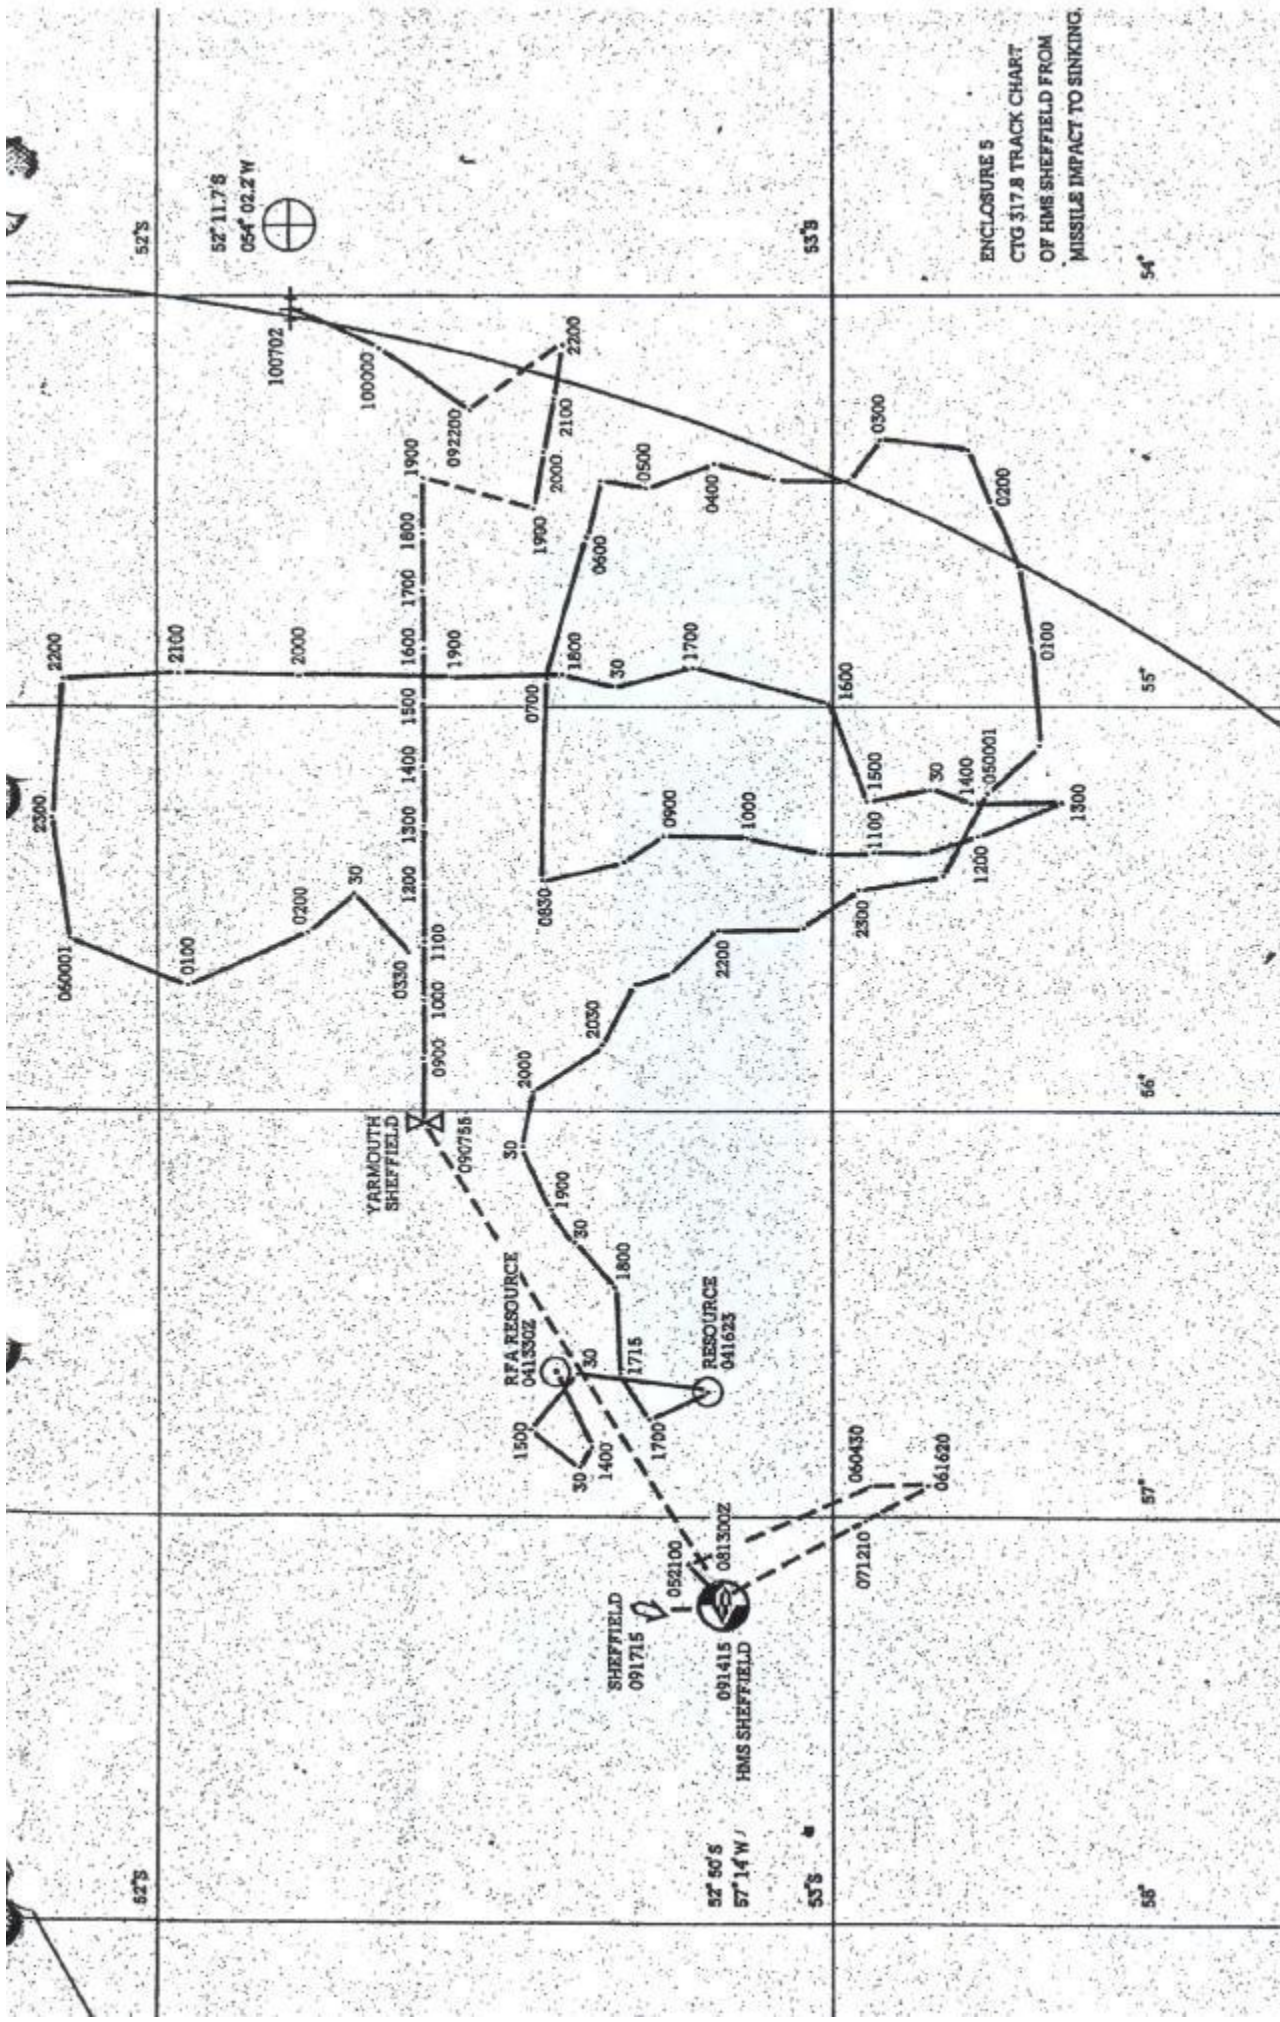
ENCLOSURE 5
 CTG 317.8 TRACK CHART
 OF HMS SHEFFIELD FROM
 MISSILE IMPACT TO SINKING.

100001-0500 Courses adjusted to keep wind fine on SHEFFIELD port bow to reduce heel and flooding through hole in starboard side.

100545 SHEFFIELD noticed to have developed a list 5° starboard. Waves washing hole in side. Altered Co 010 Sp 2.

100630 SHEFFIELD list increased 8 - 10° and difficult to control on tow.

100645-0655 SHEFFIELD list increased rapidly to 25° with hole partially submerged.

100700 Tow slipped when SHEFFIELD rolled quickly onto side.

101315 Recovered wasp. Completed search. Much debris and oil sighted but SHEFFIELD believed to have sunk in position 52° 11' S, 53° 50' W.
